TECHNICAL NOTE 3973

ORIGIN AND PREVENTION OF CRASH FIRES IN TURBOJET AIRCRAFT

By I. Irving Pinkel, Solomon Weiss, G. Merritt Preston,
and Gerard J. Pesman

Lewis Flight Propulsion Laboratory
Cleveland, Ohio

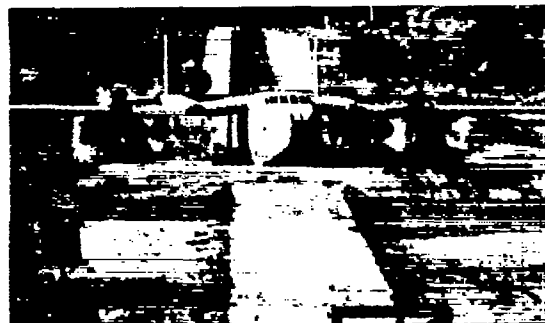
The appearance of the airplane as it struck the barrier is shown in figure 2(a). The cloud of fuel mist (liquid droplets suspended in air) that appeared when fuel spillage occurred while the airplane was in motion is evident at the breach in both wings (fig. 2(b)). Red dye in the fuel accounts for the bright color of the fuel cloud. As the crashed airplane slowed, the fuel mist moved forward of the wing and reached the air inlet on the left engine (fig. 2(c)). A strong cross wind swept the fuel mist away from the engine on the right wing.

(b) Fuel-mist cloud, 0.8 second after initial impact.

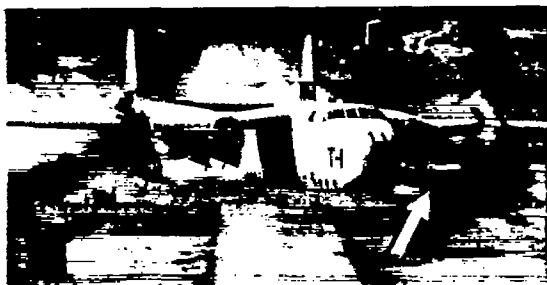
(c) Fuel mist entering left engine, 2.5 seconds after initial impact.

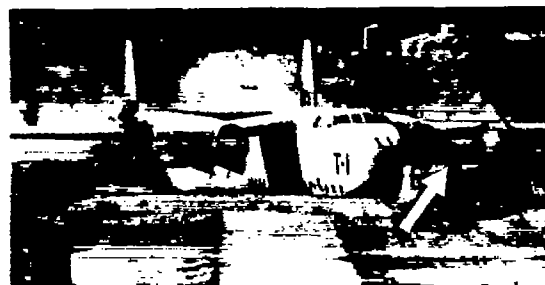
Fuel mist ingested by the left engine was ignited somewhere within the engine. The ignited fuel mist produced the flames at the tailpipe and inlet shown in figure 2(d). These exposed engine flames ignited the fuel spilling from the wing (fig. 2(e)). The flame spread through this fuel to the wing to produce the stable fire shown in figure 2(f).

Flames originating within the engine may also appear at the engine inlet as observed in figure 2(d). The appearance of this inlet flame may be explained in the following way. Burning of ingested fuel in the combustor flame reduces the turbine-inlet gas density. A higher pressure in the combustor is required to pass the gas through the turbine. When an abrupt change in over-all combustor fuel-air ratio is provided by the ingested fuel, the pressure in the combustor required to pass the combustor gas through the turbine may exceed the capability of the compressor at the existing rotor speed. The compressor flow may stall before the turbine can accelerate the rotor to a speed that will provide the necessary pressure. At this moment the combustor flame may propagate upstream through the ingested combustible mixture that fills the stalled compressor and exit at the engine inlet.

(d) Fire at engine inlet and tailpipe of left engine, 2.6 seconds after initial impact.

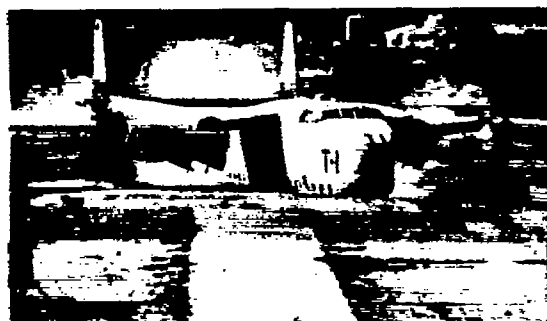
(e) Fire spread to fuel mist issuing from left wing, 2.8 seconds after initial impact.

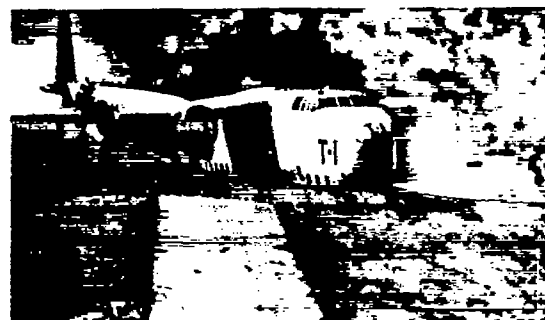
(f) Spread of fire, 4.0 seconds after initial impact.

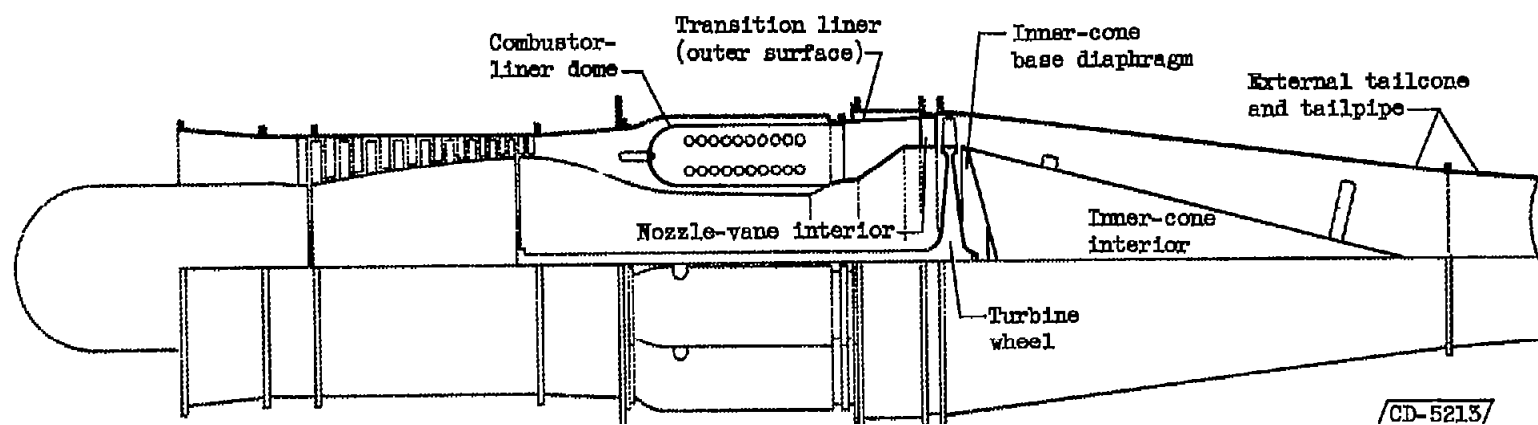
The ignition zones were identified in test-stand engines by the method discussed in detail in appendix C. The technique employed involved the use of fuel sprays local to the engine zone suspected as an ignition source. Following engine operation at rated conditions for a time sufficient to establish temperature equilibrium, the fuel flow to the combustor was turned off and the fuel spray was turned on local to the zone under study. The fuel flow was programmed to maintain a combustible atmosphere in the zone. If ignition occurred, inerting means were installed to prevent the ignition in subsequent tests of upstream zones. By starting at the downstream end of the engine and proceeding upstream in this way, each ignition zone was identified and inerted in turn. As a final check after all the zones were inerted, fuel was injected into the main gas stream to determine whether ignition would occur. In this manner, ignition zones were found on the combustor liner, transition liner, turbine and inner-cone base diaphragm, and tailcone and tailpipe (fig. 11).

Figure 11. - Hot-metal ignition zones found in J35 engine.

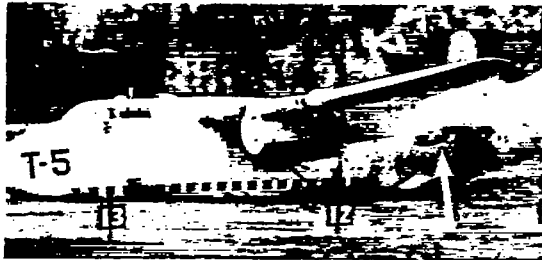
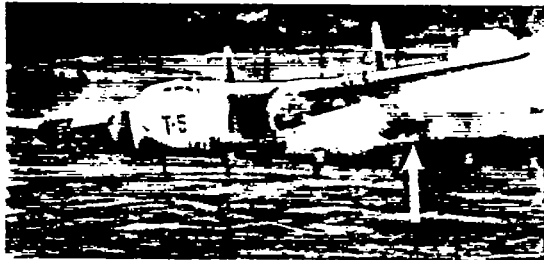
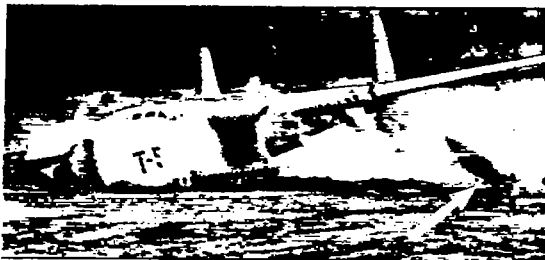
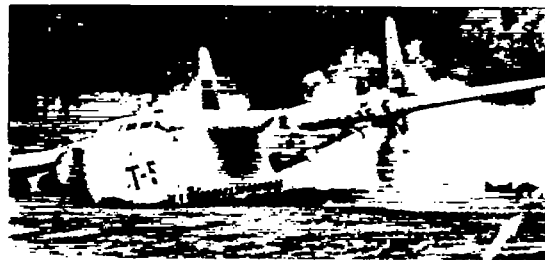
Separation of the engine from the wing is shown in the picture sequence of the crash in figure 24. After separation (fig. 24(a)) the engine tumbled in the fuel spraying into the wake of the damaged wing (figs. 24(b) and (c)) and came to rest in the fuel-wetted slide path of the airplane (fig. 24(d)). The plume of condensed water vapor at the tailpipe (fig. 24(a)) shows that the water inerting system was actuated. No fire occurred.

Figure 24. - Separation of J47 engine from C-82 wing in crash.

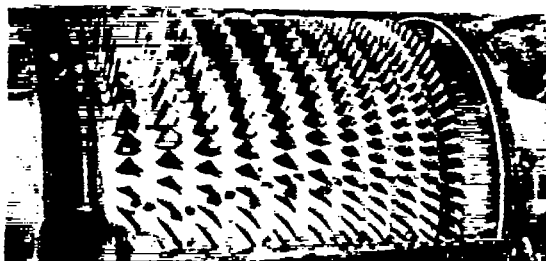
The sequence of events following crash were the same for the F-84 as for the cargo airplanes. Poles at the crash barrier ripped open the wing fuel tanks and produced the fuel mist shown in figure 25(a). Collapse of the nose gear allowed fuel from the torn forward fuselage tank to enter the engine inlet. Vapor issuing from the tailpipe (fig. 25(b)) was provided in part by the fuel that passed through the engine from the damaged fuel tank adjacent to the engine inlet. Evaporation of water from the fire protection system contributed a large part of the vapors formed (fig. 25(b)). Inspection of the engine after crash showed the telltale dye stains left by the red-dyed fuel flowing through the compressor (fig. 26). No fire occurred.

Figure 26. - Fuel-dye stains on J35-engine compressor following F-84 crash.
